III. SUMMARY OF THE PHASE I/II HISTORIC RESOURCES SURVEY

A Phase I/II historic resources survey was conducted for the proposed Choptank Road project. The purpose of this survey was to identify all buildings and structures, fifty years in age or older, situated within the Area of Potential Effect (APE) for the project. The following discussion presents a summary of the results of the Phase I/II historic resources survey. The locations of the historic resources identified by this survey are presented in **Figure 2**.

C. Survey Results

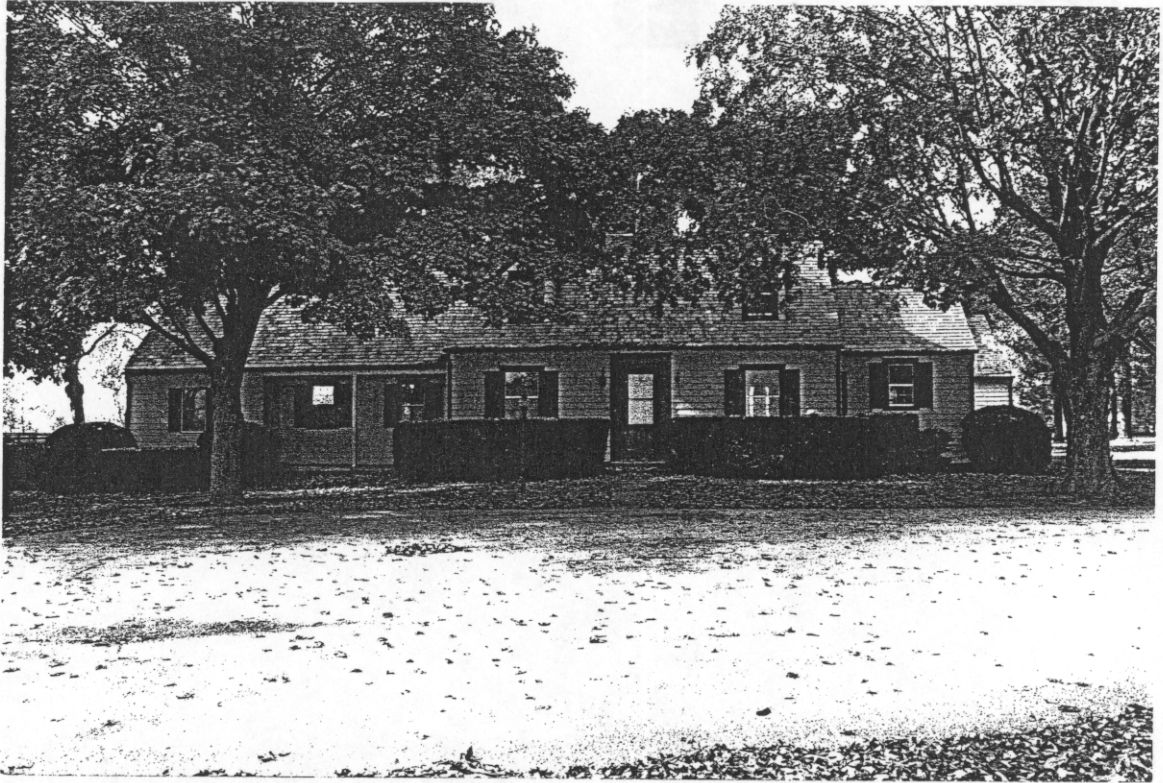
The main house of the Sharp Farm (1210 Sharp Lane) was constructed c. 1940 in the Neocolonial, or more commonly called Cape Cod style, with later additions constructed in 1957 (*See Photograph 3*). The building stands one and a half stories tall with a side gable roofline. The front (east) façade features a central entry flanked by eight-over-eight double hung sash. The roof is clad in wood shakes and the front slope features two gabled dormers. One-story additions were constructed onto the north and south facades. The three bay long addition to the south features an inset porch and sliding glass doors on the southern gable end. The one bay addition to the north was altered later in the building's development by a subsequent one-story addition to the north, which features a three-bay breezeway connecting to a two bay gable-facing garage. The exterior walls throughout the house are covered with vinyl siding; however the walls of the garage are constructed of cement block. The rear (west) façade of the house features a three bay shed roof dormer and paired six-over-six box bay windows.

Photograph 3: N-14080, main house of Sharp Farm, view of front (east) facade, facing west.

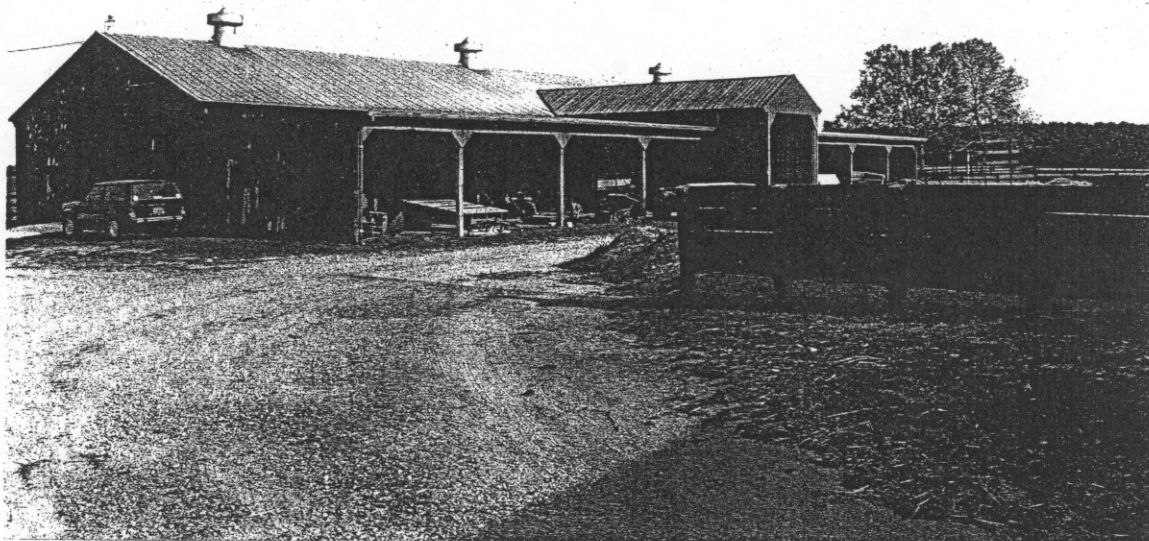
There are several auxiliary barns, sheds, and stables throughout the property that house equipment that date to the 1960s (*See Photographs 5-8*). North of the modern equipment shed is a complex of such buildings. The grouping closest to the driveway, also known as Sharp Lane, is a one-story side gable shed with two bays with wood sliding doors on the south façade. The walls are clad with wood shingle. This shed is attached to a U-shaped, saltbox series of stables that have vertical board siding. Behind this series of buildings to the north is a barn with a side gable principal roof and a shed and cross-gable secondary roof extending to the south. The walls of this building are clad in vertical board and the roof in standing seam metal. The south façade features eight open bays for equipment storage.

Photograph 5: N-14080, equipment shed of Sharp Farm, facing west.

Photograph 6: N-14080, barn and stables at Sharp Farm, facing northeast.

Photograph 7: N-14080, barn/equipment shed at Sharp Farm, facing northeast.

Photograph 8: N-14080, stables at Sharp Farm, facing west.

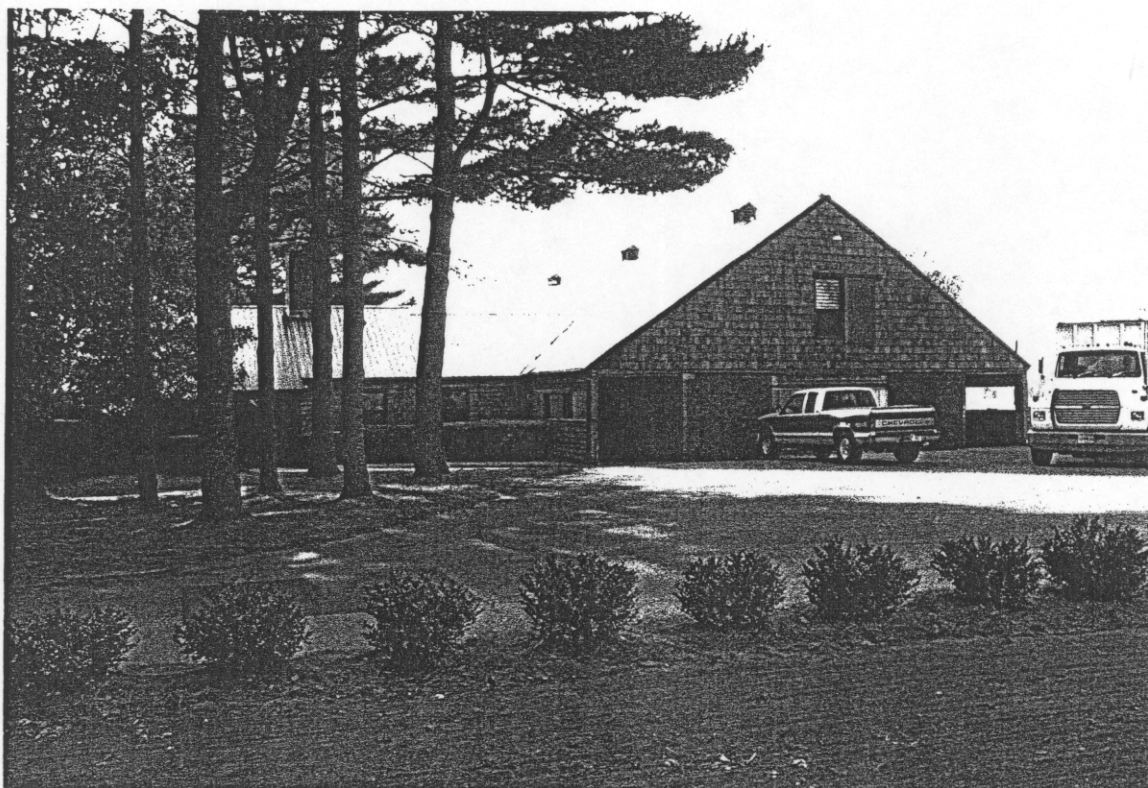
Southeast of the bunkhouse and north of the main residence are the onsite administrative offices (1214 Sharp Lane) of the Sharp Farm (*See Photograph 10*). The barn that is attached to the administrative office is the only remaining building from the farm previously on the site; however, it has been greatly altered throughout the years to accommodate the needs of the horse farm. The most recent alteration to the building took place in 1981 when the one-story side gable office addition was constructed. The barn features a low-pitched gable-facing roof covered with standing seam metal. There are two bays with sliding wooden doors on the northern and southern gable ends. The exterior walls are clad in wood shingles. Both the eastern and western facades feature a full-length ribbon of horizontal sliding window.

Photograph 10: N-14080, barn/administrative office at Sharp Farm, facing southwest.

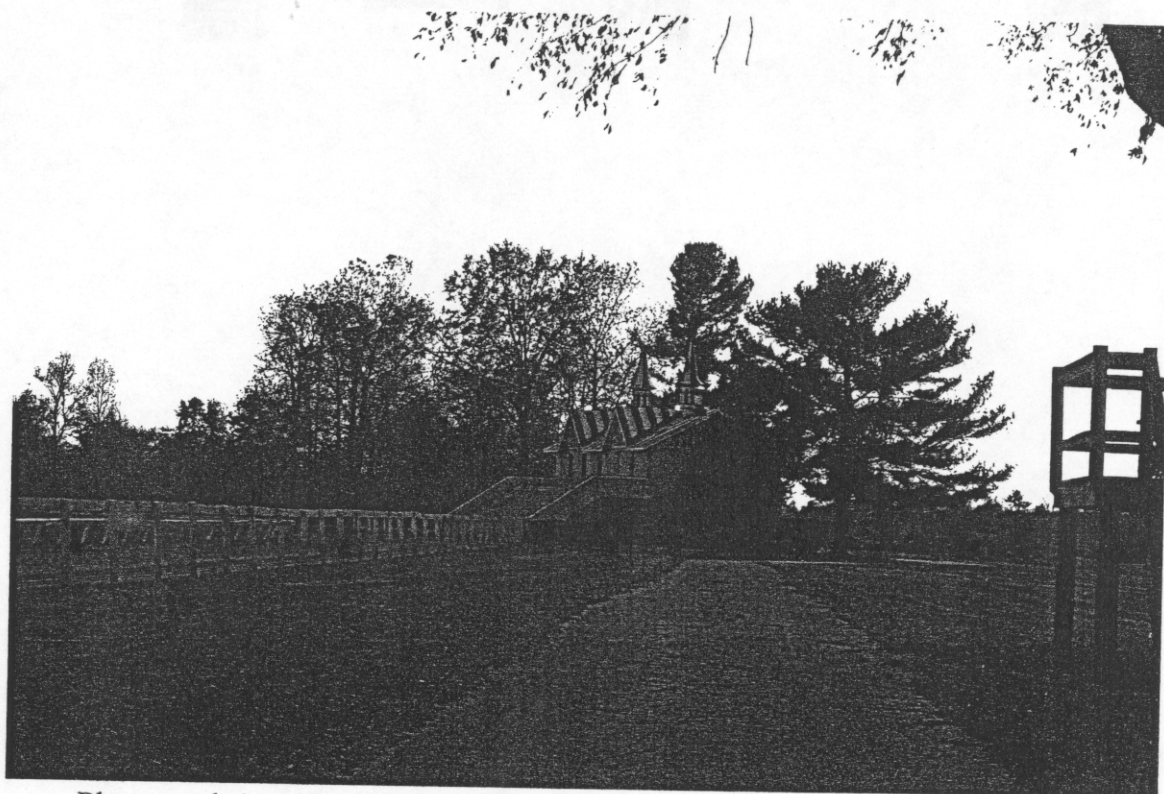
South of the main house and complex of buildings described above is the racetrack and track house constructed c. 1969 (*See Photograph 11*). The racetrack has two surfaces for different styles of racing, a sand inner track and a grass outer track, all of which is surrounded by a white post and rail fence. Adjacent to the racetrack is the track house (1202 Sharp Lane). This building was constructed to resemble Churchill Downs, home of the Kentucky Derby. The two story building features grandstand seating on the east façade. The side gable roof features two cross gables on the front (east) and rear (west) slopes, each topped by a spire. The panels of the metal roof are painted alternately in white and black. The gable ends and peaks of the cross gables are also decorated with Queen Anne style verge board and alternately painted black and white. The exterior walls of this building are clad with vertical board siding.

Photograph 11: N-14080, track and track house at Sharp Farm, facing south.

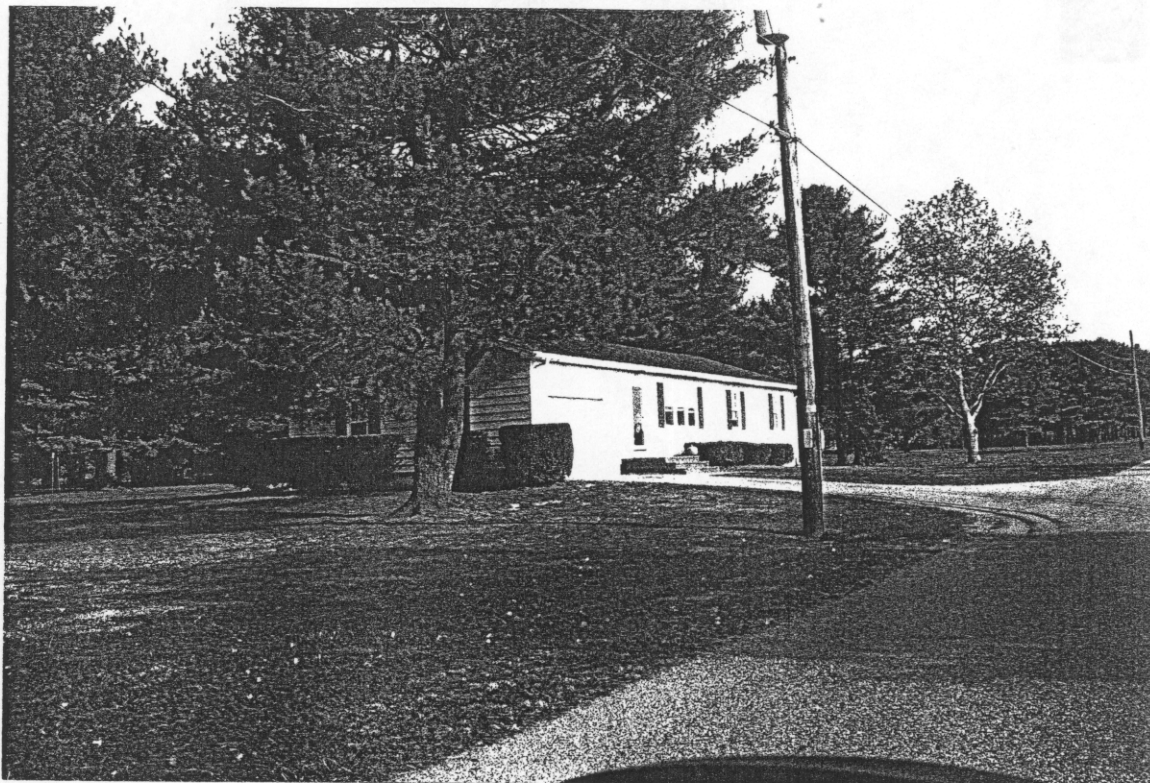
There are six houses that were constructed between 1969 and 1983 for employees of the Sharp Farm. Three of these houses are situated along Sharp Lane, one along Choptank Road, and two along Bohemia Mill Road. The residence at 1135 Sharp Lane was constructed c. 1969 in the Ranch style (*See Photograph 13*). It features five bays on the south façade, one of which is a one-car garage on the southwestern corner. The side gable roof is covered with asphalt shingles and the exterior walls with vinyl siding.

Photograph 13: N-14080, view of 1135 Sharp Lane, facing northeast.

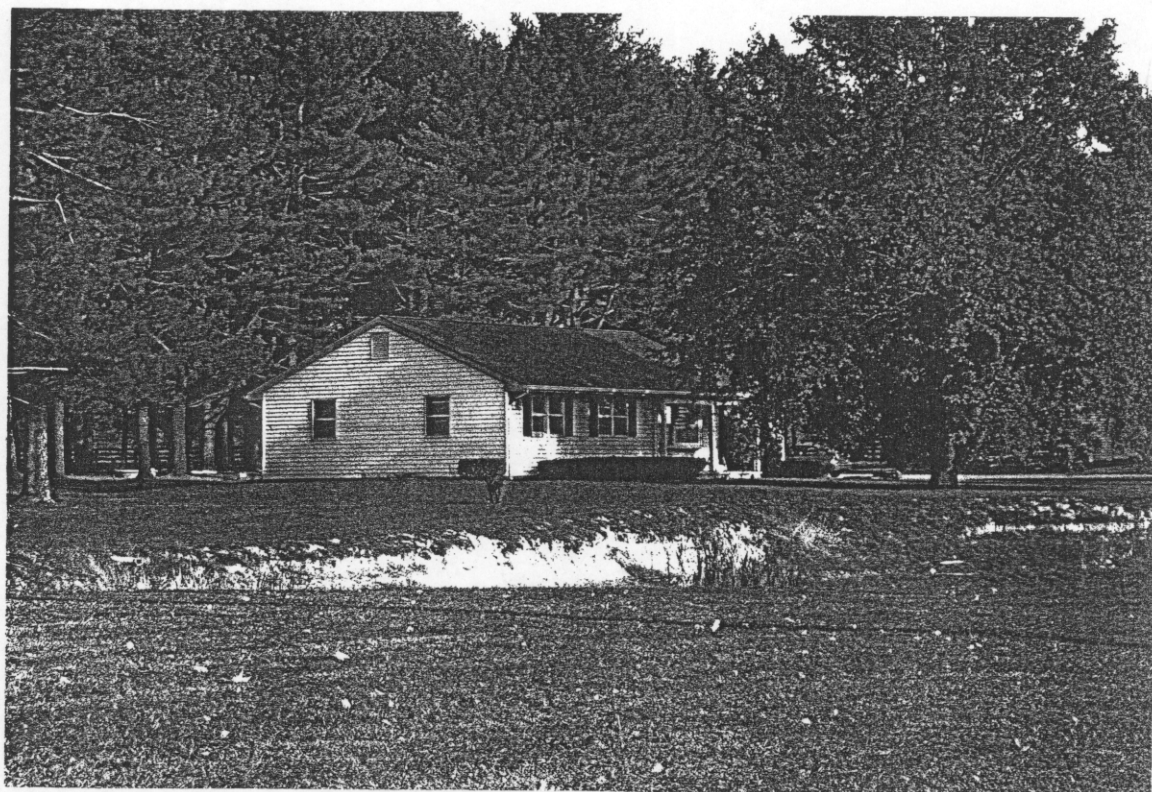
The residence at 1119 Sharp Lane is also a Ranch style house constructed in 1983 (*See Photograph 14*). The front (south) façade features two paired one-over-one windows at the southwest corner; the southeast corner features a recessed porch protecting the entry and a bay window. The side gable roof is covered with asphalt shingles and the exterior walls with vinyl siding.

Photograph 14: N-14080, view of 1119 Sharp Lane, facing northeast.

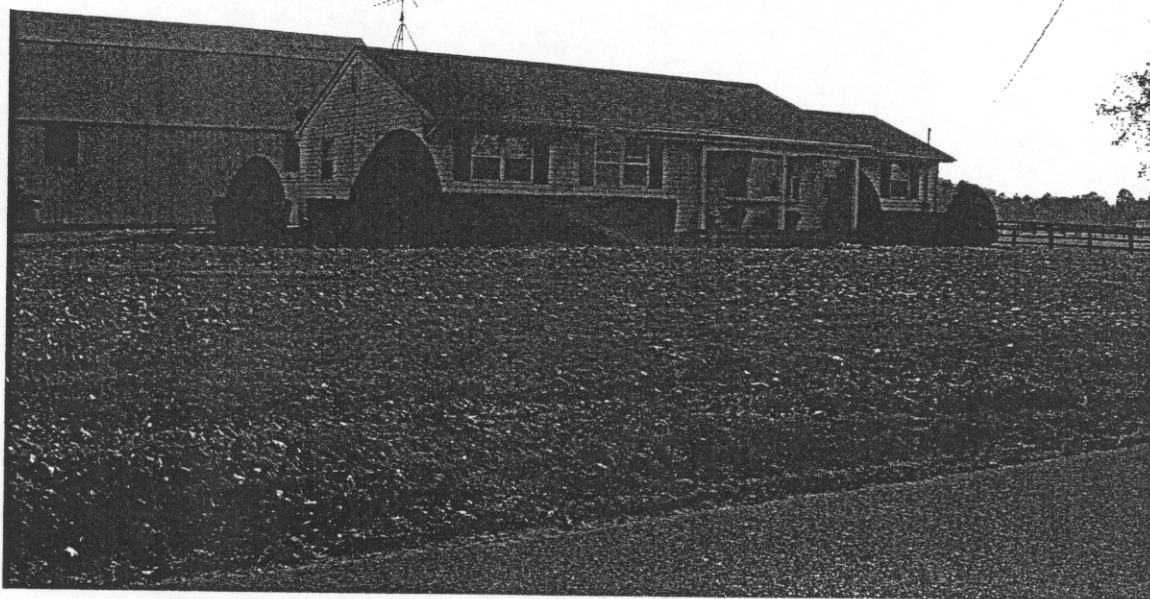
The residence at 1132 Bohemia Mill Road is a 1983 Ranch style house, similar to those houses located at 1111 and 1119 Sharp Lane (*See Photograph 17*). The front (north) façade features paired one-over-one aluminum frame sash in the northeast corner and a recessed entry porch on the northwest corner. An attached one-car garage has been added to the west façade of the house. The side gable roof is covered with asphalt shingles and the exterior walls in vinyl siding. South of this property is a gambrel roof barn and a one-story hipped roof stable, both with standing metal seam roofs and vertical board siding.

Photograph 17: N-14080, view of 1132 Bohemia Mill Road, facing southwest.

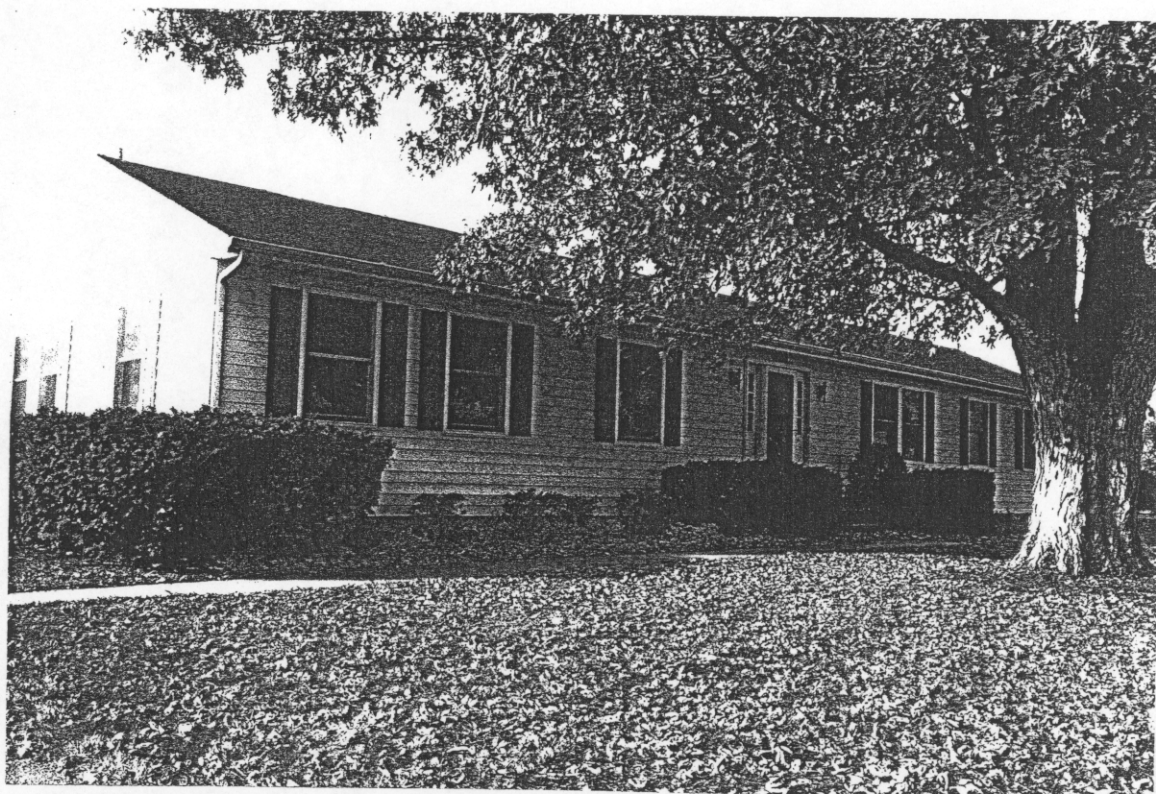
Photograph 18: N-14080, view of 2131 Choptank Road, facing west.

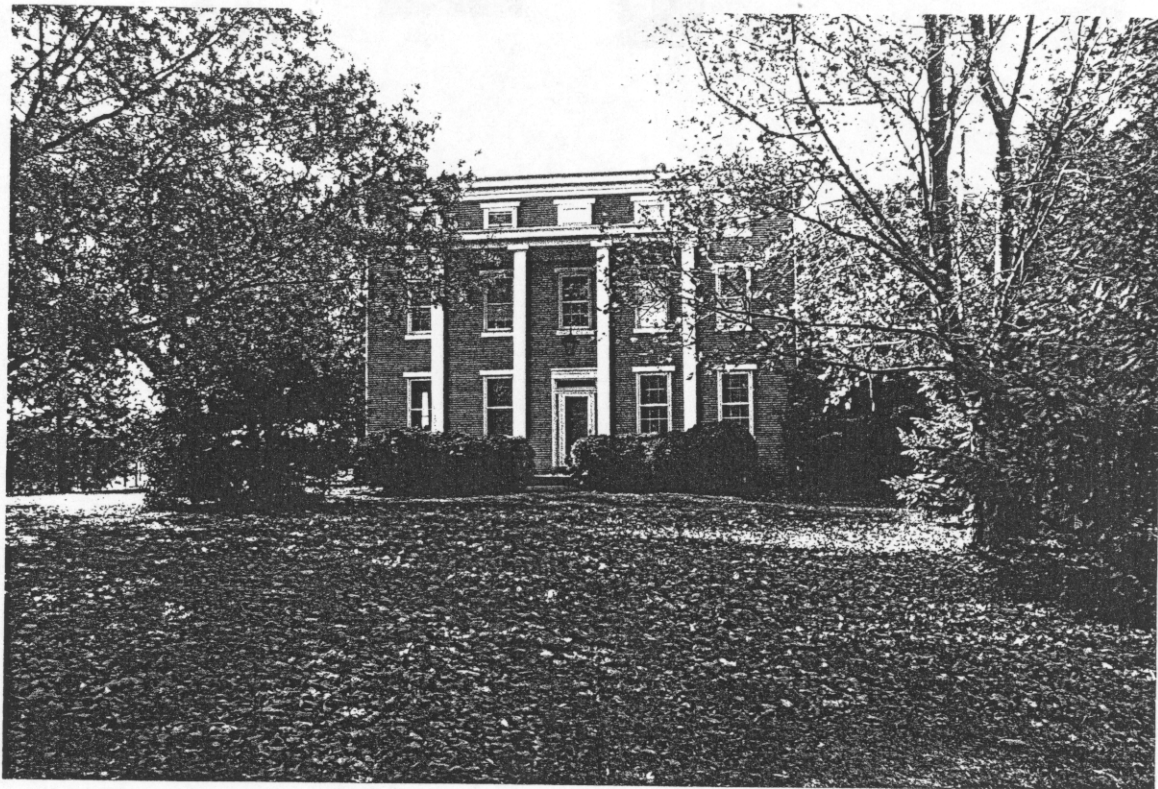
Photograph 19: N-108, view of front (east) facade, facing west.
